# Orla

## Technical expertise

### **EKSPERTYZA TECHNICZNA** z oceną stanu mykologicznego budynku

**Budynek zabytkowej synagogi**  
(wpisany do rejestru zabytków pod nr A-411)

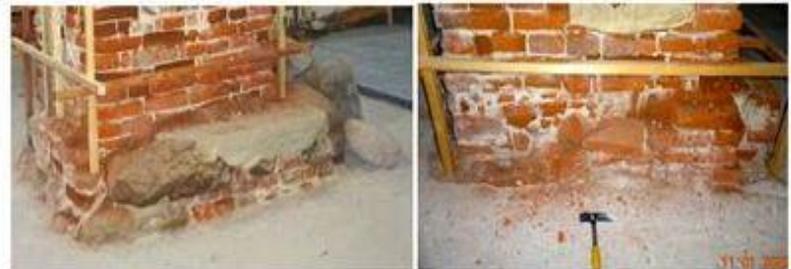
Fot.30 Uszkodzona podstawa filara Nr2 ....

... i filara Nr3

1. Wykonać doraźną reperację podstawy filarów Nr 1-4 (oznaczenie na rzucie parteru – Załącznik Nr 1 do niniejszej ekspertyzy) za pomocą cegły pełnej, czerwonej, o wytrzymałości na ściskanie min. 12 MPa i zaprawy cementowo-wapiennej marki min. 5MPa. Zachować oryginalne wymiary obrysu.

1. Repair of the base of the pillars with solid, red brick and cement-lime mortar;
2. Repair the gap in the roof;
3. Repair of vertical and diagonal wall stratifications of the structural wall. Works should be done from the inside and outside to the depth of one brick;
